COMMON INSTALLATION ISSUES WITH CERAMIC BASINS

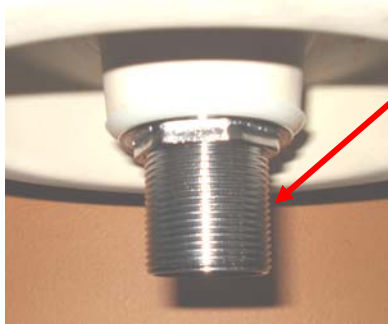
Leaking from overflow wastes occur down the thread if not sealed correctly.

(If the outer thread is wet, then the overflow waste is not sealed correctly.)

Use of plumbers putty (or silicone) around the thread prior to fitment of the rubber seal and nut will prevent water egress.

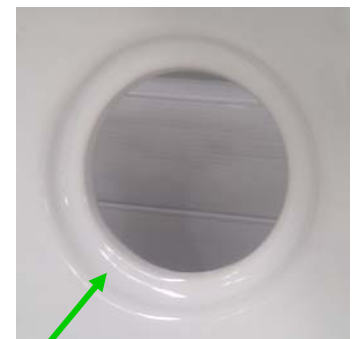
Leaking between the basin and the waste.

Use plumbers putty or silicone to seal the top of the basin waste hole

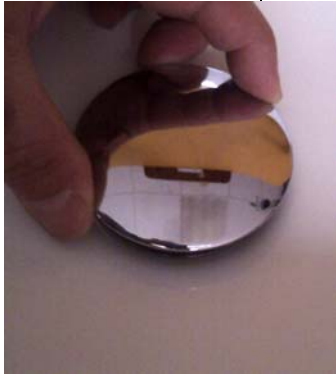
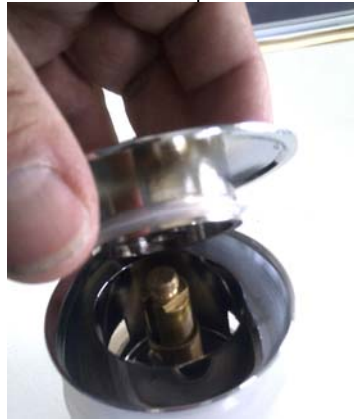
Unscrew the chrome dome from the plunger.

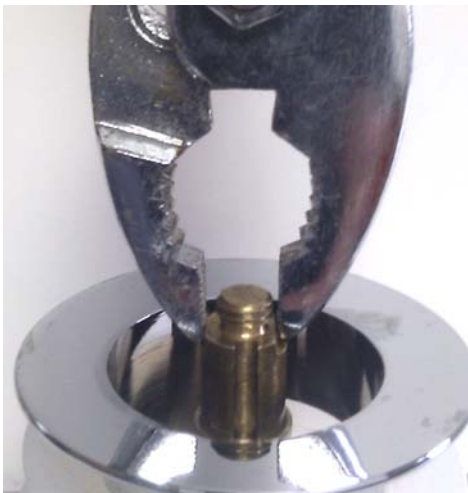
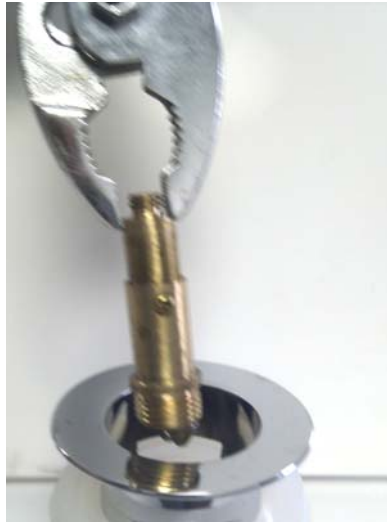
Using a pair of pliers, grip the flat end of the plunger and unscrew the plunger from the waste body.

BE CAREFUL TO NOT GRIP THE THREAD

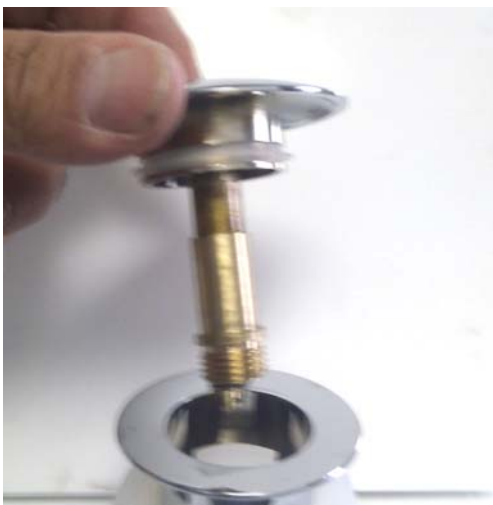
Refit the new plunger and dome and screw into the waste body.

Test for correct operation.
